September 16, 2009

Re: Old Fort Benton Catholic Church of the Immaculate Conception
Site Investigation

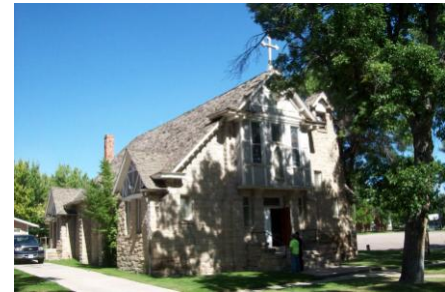
1. During the site inspection it was explained to me that the roof leaks. This seems apparent due to the age and appearance of the roof (see photo to the right) and the signs of water stains on the underside of the structure. From what we could see during our inspection, there was no roof or wall insulation that could be detected.

1. Replace the roof. Since it appears there is no roof or wall insulation, it may be possible to install insulation under the roof slats during the roof replacement. This will make the building more energy efficient. Adding wall insulation will not be possible unless an additional stud wall is added to the inside of the building which can hold insulation (not considered in the estimate).

Construction estimate to reroof including the east side wall = **\$40,000**

Construction estimate to remove slats, apply roof insulation, resheath = **\$35,000**

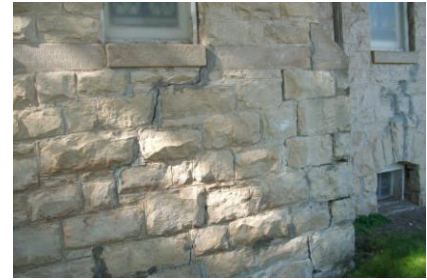
5. There are cracks or gaps in the mortar along the outside of the foundation wall and rock upper wall with some of the cracks up to 1" wide. There are also areas in the church where the mortar between the interior orange clay tile is cracked (especially noted on the north wall near the stairs). Many of these areas over the years have been patched with a grout or cement based product (see photo to the right).

4. Repair cracks and gaps in the mortar of the exterior upper rock walls and the lower foundation walls and columns exposed inside the basement and the crawlspace of the church using a masonry mortar. On the outside, try to match the color of the mortar close to the existing color. Before applying the mortar, make sure the cracks are cleaned out and any loose mortar is removed. It may be beneficial to excavate down around the outside of the foundation wall and determine the need to patch the foundation wall below grade. If the mortar is deteriorated, this should be included in the repairs.

Construction estimate for repairing and patching wall gaps and cracks = **\$90,000**

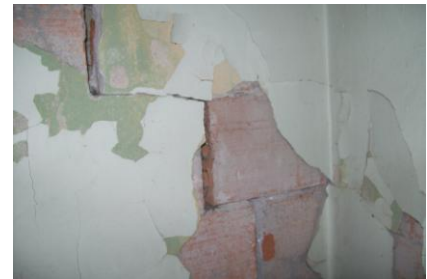
6. There are cracks in the interior wall plaster placed on the clay tile throughout. This is usually a result of walls shifting from settlement or from age (see photo to the right).

7. Repair all other items including: replastering the interior walls, refinishing the floor, painting the interior and exterior where required, thoroughly cleaning, etc.. No construction cost estimate was provided for these non-structural items.

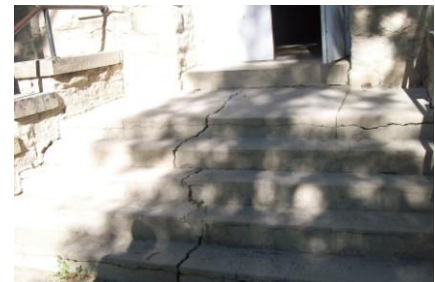
8. There are cracks in the entry steps likely resulting from loosely compacted soil below the concrete. The front steps slope down to both sides (see photo to the right).

2. Replace the front steps (east side) and the south steps. This can be performed by demolishing the concrete and pouring new concrete. It may also be possible to grind smooth the existing front concrete steps (east side) and patch the crack with an epoxy concrete product (Sika) although this would be a temporary repair and would not fix the slope on the steps. The south stairs would need to be replaced entirely.

Construction estimate to replace south and east concrete steps = **\$5,000**

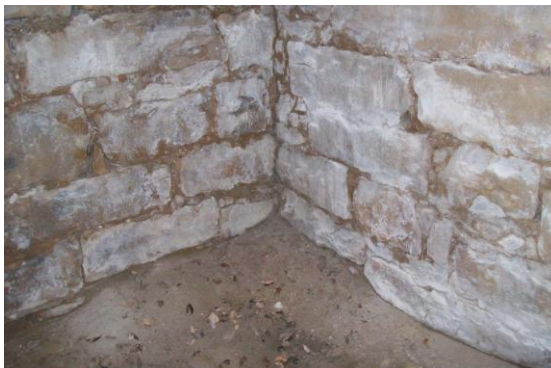
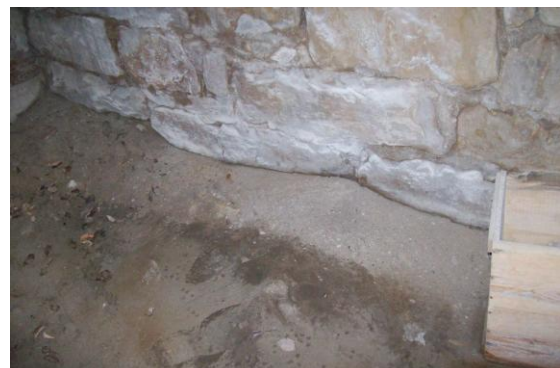
9. Mortar in the rock foundation walls and in the exterior rock walls is deteriorating and falling out from the joints to the base of the walls. This is likely the result of the original lime mortar deteriorating over time which can be common in a structure this old. The deterioration is severe near the base of the rock wall outside possibly due to sprinklers speeding up the deterioration process. It is also severe in the exposed areas of the basement foundation walls. Some areas of severe deterioration have 2" or more of the mortar deteriorated (see photos below).

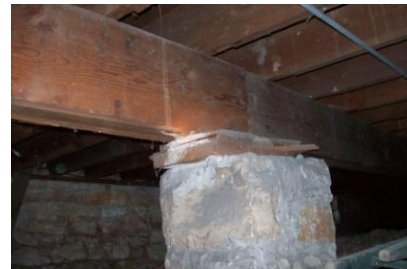
11. In the past, the tops of the basement columns have been shimmed and/or regouted and releveled. Indications of releveled columns can be seen by the timber shims and sometimes grout placed under the floor system beams (see photo to the right). It is possible that the columns at one time had settled and this was done to relevel the columns. However, as our floor elevation survey noted, the floor is generally higher in the middle. This is possibly due to over correcting during the releveling of the floor or due to clay soil heave under the columns after the releveling was performed.

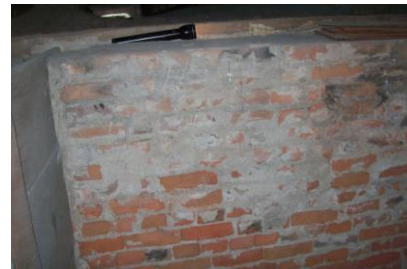
12. Deteriorated brick retaining wall in the basement. This appears to be unfired brick that overtime has deteriorated. While it is deteriorating it doesn't appear to be an immediate structural threat (see photo to the right).

6. Repair the collapsing retaining walls in the basement. The timber wall can be replaced using a railroad tie post embedded in the earth every 5' in a 12" diameter concrete hole (min. 3' depth) to support newly placed horizontal railroad ties to resist the lateral earth pressures. The deteriorating brick retaining wall is still standing but can be replaced with a similar post and railroad tie system.

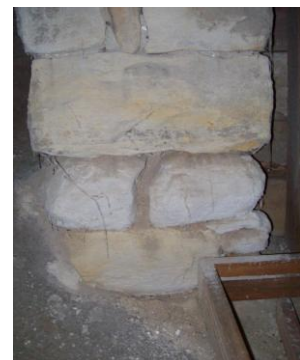
13. Severe deterioration of the mortar in the basement columns with some areas between the rocks containing very little mortar left (see photo to the right).
